SECTION 32 PROGRAM
STREAMBANK EROSION CONTROL
EVALUATION AND DEMONSTRATION
WORK UNIT 2-EVALUATION OF EXISTING
BANK PROTECTION

FIELD INSPECTION OF SITES IN THE VICKSBURG DISTRICT
IN THE UPPER YAZOO BASIN

Malcolm P. Keown, E. A. Dardeau, Jr.

October 1978

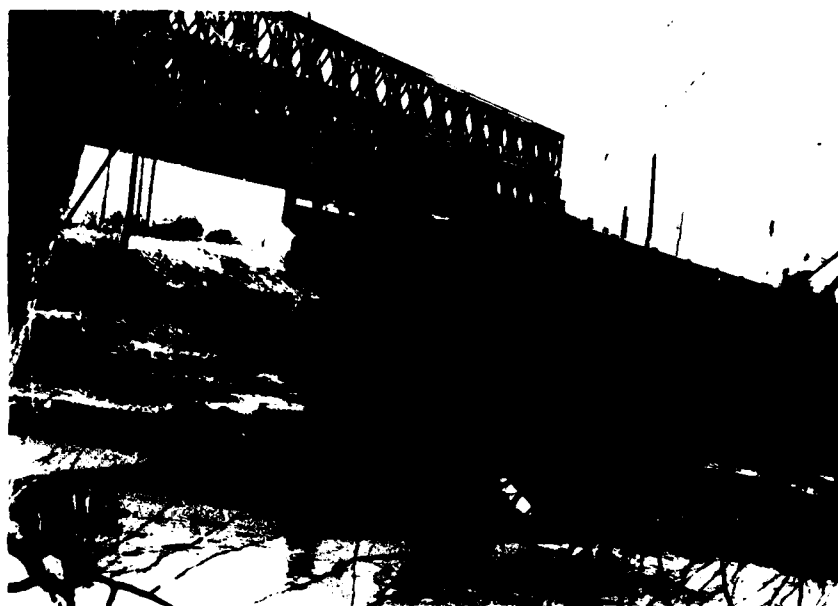
Figure 1. Bailey bridge assembled at the Mississippi State Highway 8 crossing of Batupan Bogue after failure of the permanent structure during the 21 November 1977 storm event (25 January 1978)

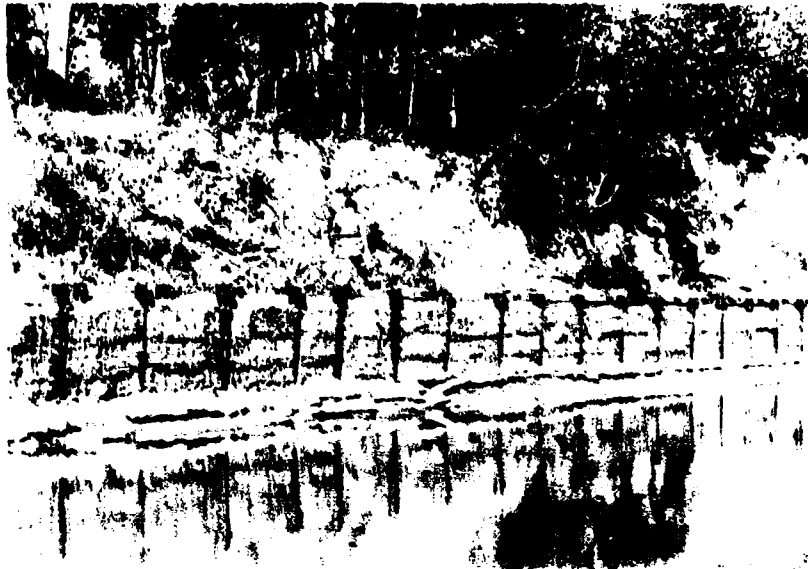
Figure 28. Hay-filled wire crib retained following failure
downstream - percent for the protection of South Fork
Tillatoba Creek (11 October 1977)

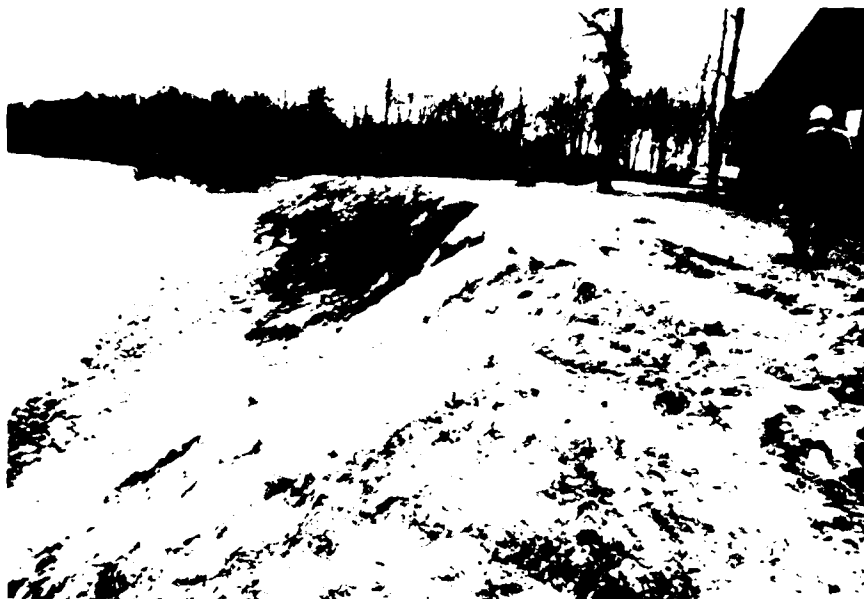
Figure 68. Serious scour occurred on the upper bank in Work Area 6 during the 21 November 1977 storm event, Batupan Bogue (25 January 1978)

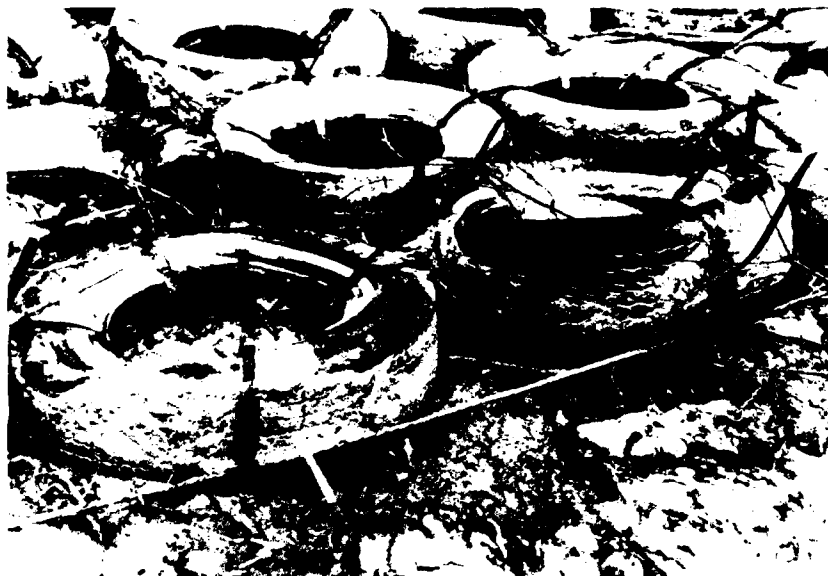
18. The bank protection in Work Area 8 consists of used tires held together with steel straps and cables attached to screw-type anchors (Figures 72, 73). This tire protection extends from 5 to 10 ft riverward from the bank toe and up to one third to one half of the bank height. The bank slope above the tires will be vegetated with Type II mulch (Table 2) and willow sprouts. In addition, willow sprouts were planted in each tire. The upper bank vegetative treatment had not been placed at the time of the 21 November 1977 storm event; however, the bank had been graded to specifications. Damage to the tire revetment in this work area was minimal (Figure 74); some upper bank failure occurred as shown in Figure 75.

Figure 72. Used tires held together with steel straps and cables, Work Area 8, Batupun Borue (25 January 1978)

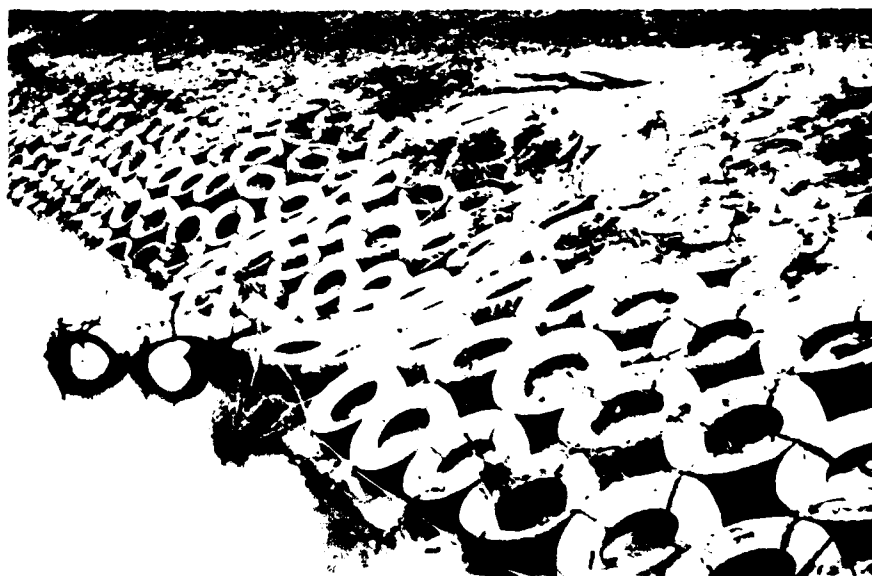
Figure 73. Used-tire revetment, Work Area 8, Batupun Borue (25 January 1978)
